CITY OF JOHNSTON
SURFACE WATER
MONITORING
2016 WATER QUALITY MONITORING
SUMMARY

DECEMBER 2016

The State Hygienic Laboratory at the University of Iowa (SHL) collected water samples at eleven sites in the City of Johnston on October 19, 2016. Included with this report is a summary table of the results, pictures and notes from each site, and an appendix with reports generated from our Laboratory Information Management System (LIMS).

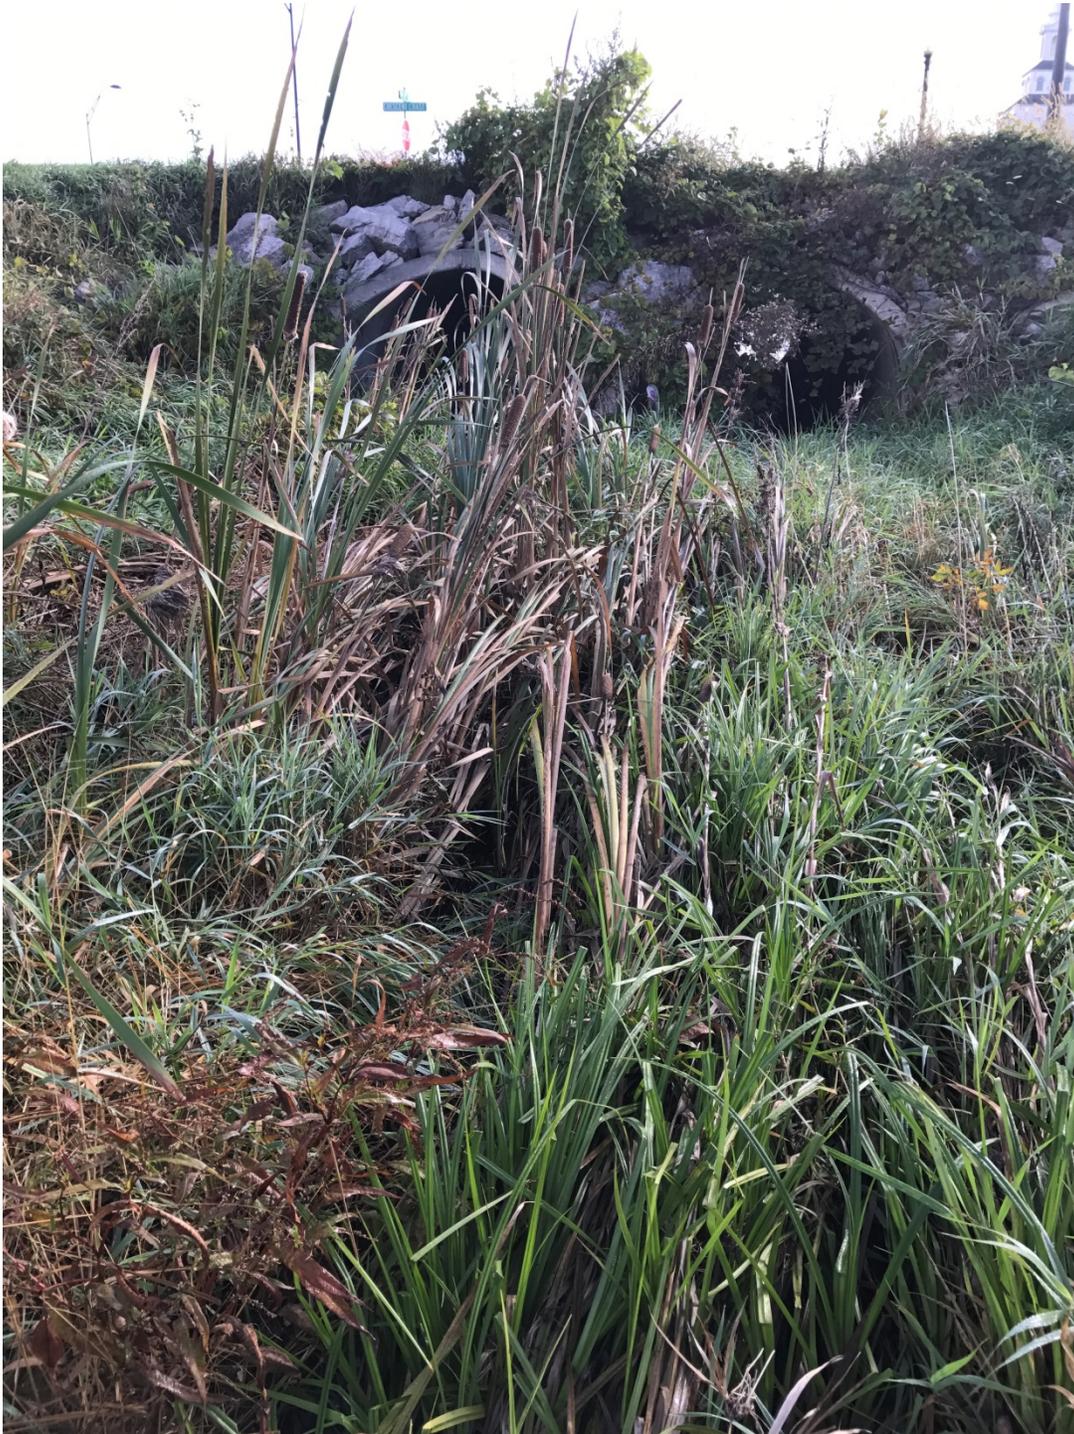
Figure 1. Looking downstream from Site 11 on October 19, 2016. Collector's comments: "Clear water, little to no algae. Good flow."

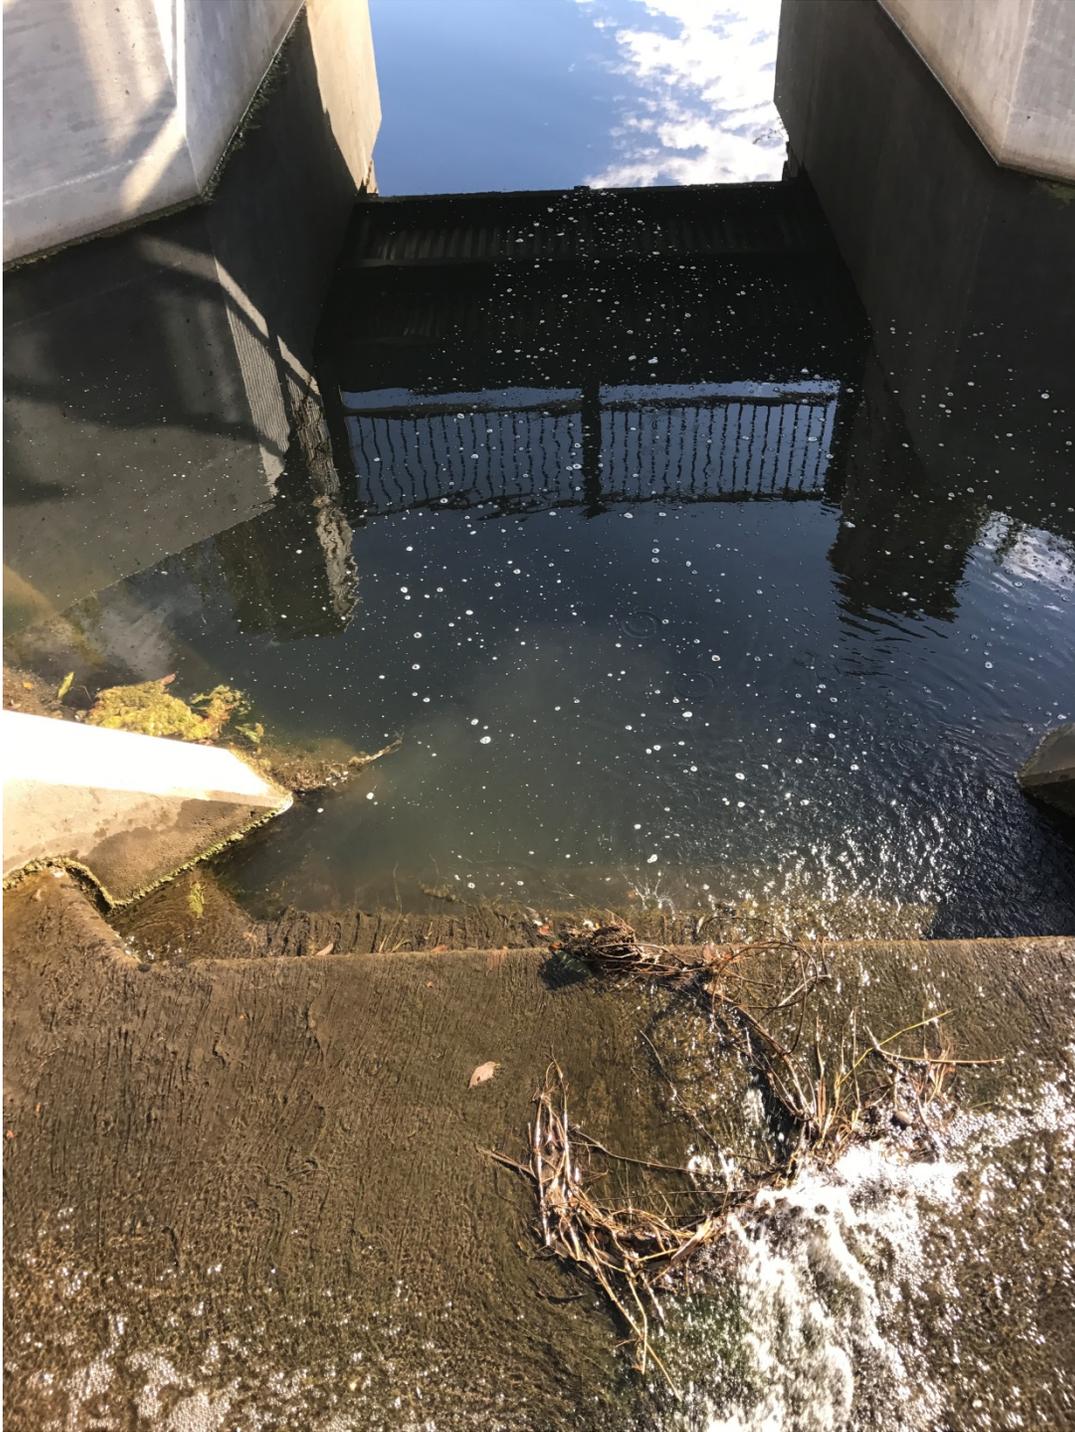
Figure 3. Looking downstream from Site 12 on October 19, 2016. Collector's comments: "Large abundance of surface algae, filamentous algae, and aquatic vegetation. Water semi-green."

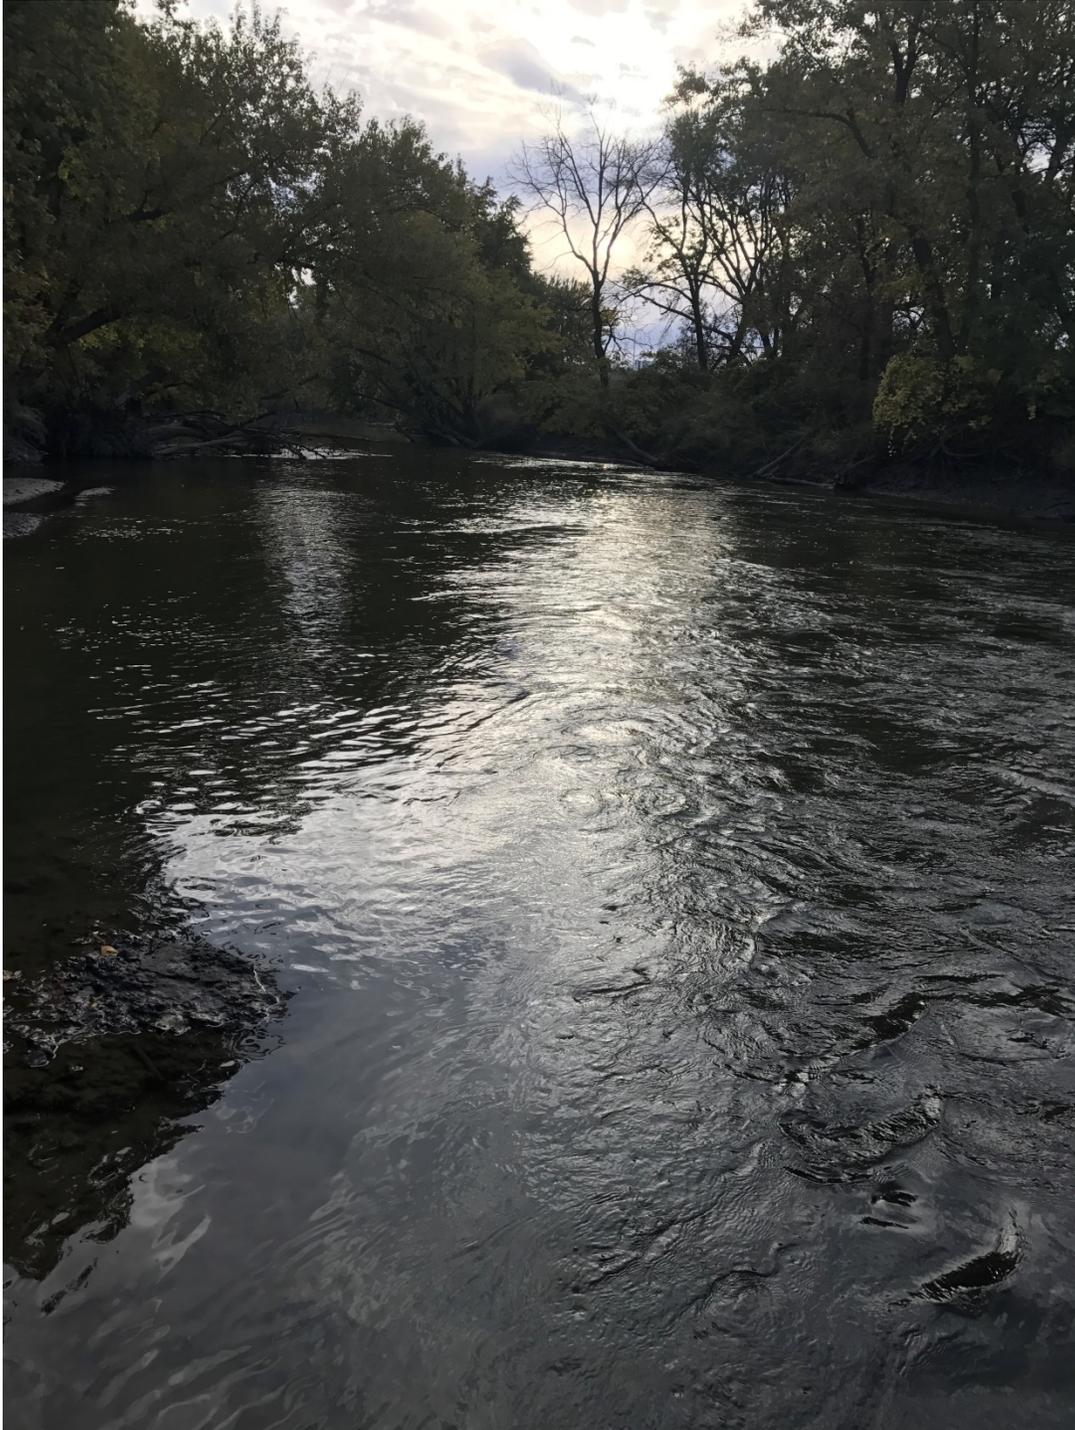
Figure 5. Looking downstream from Site BC1 on October 19, 2016. Collector's comments: "Heavy flow, water semi-clear, semi-green. No aquatic vegetation."

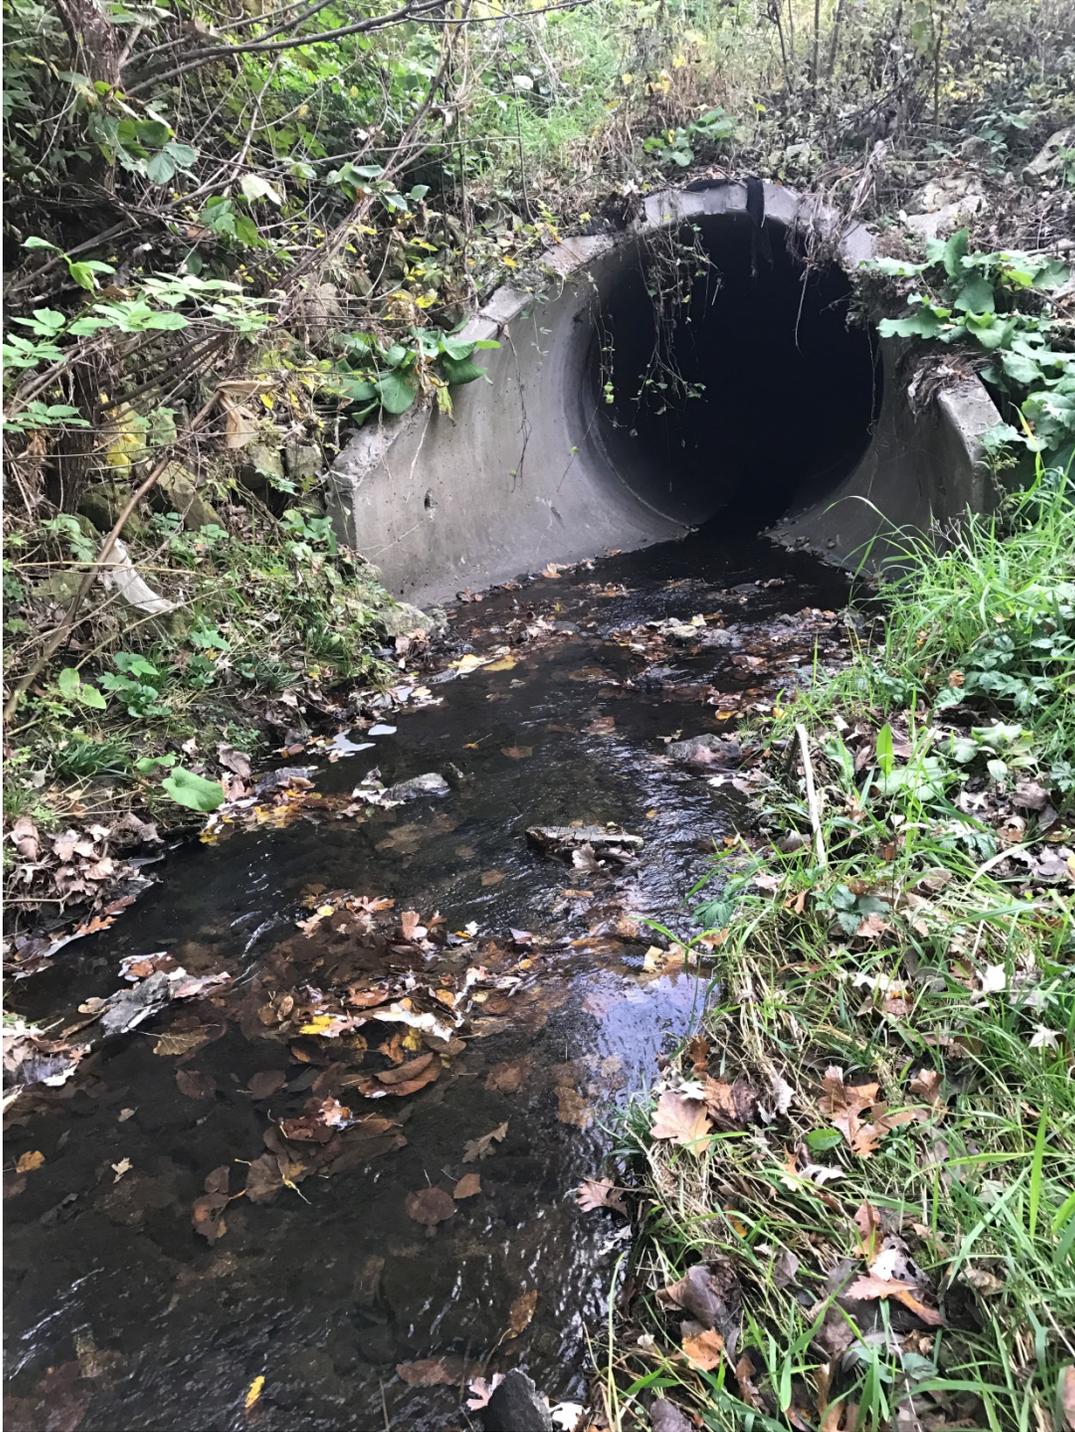
Figure 7. Looking downstream from Site C2 on October 19, 2016. Collector's comments: "Clear water, little to no algae, moderate flow and an abundance of leaves."

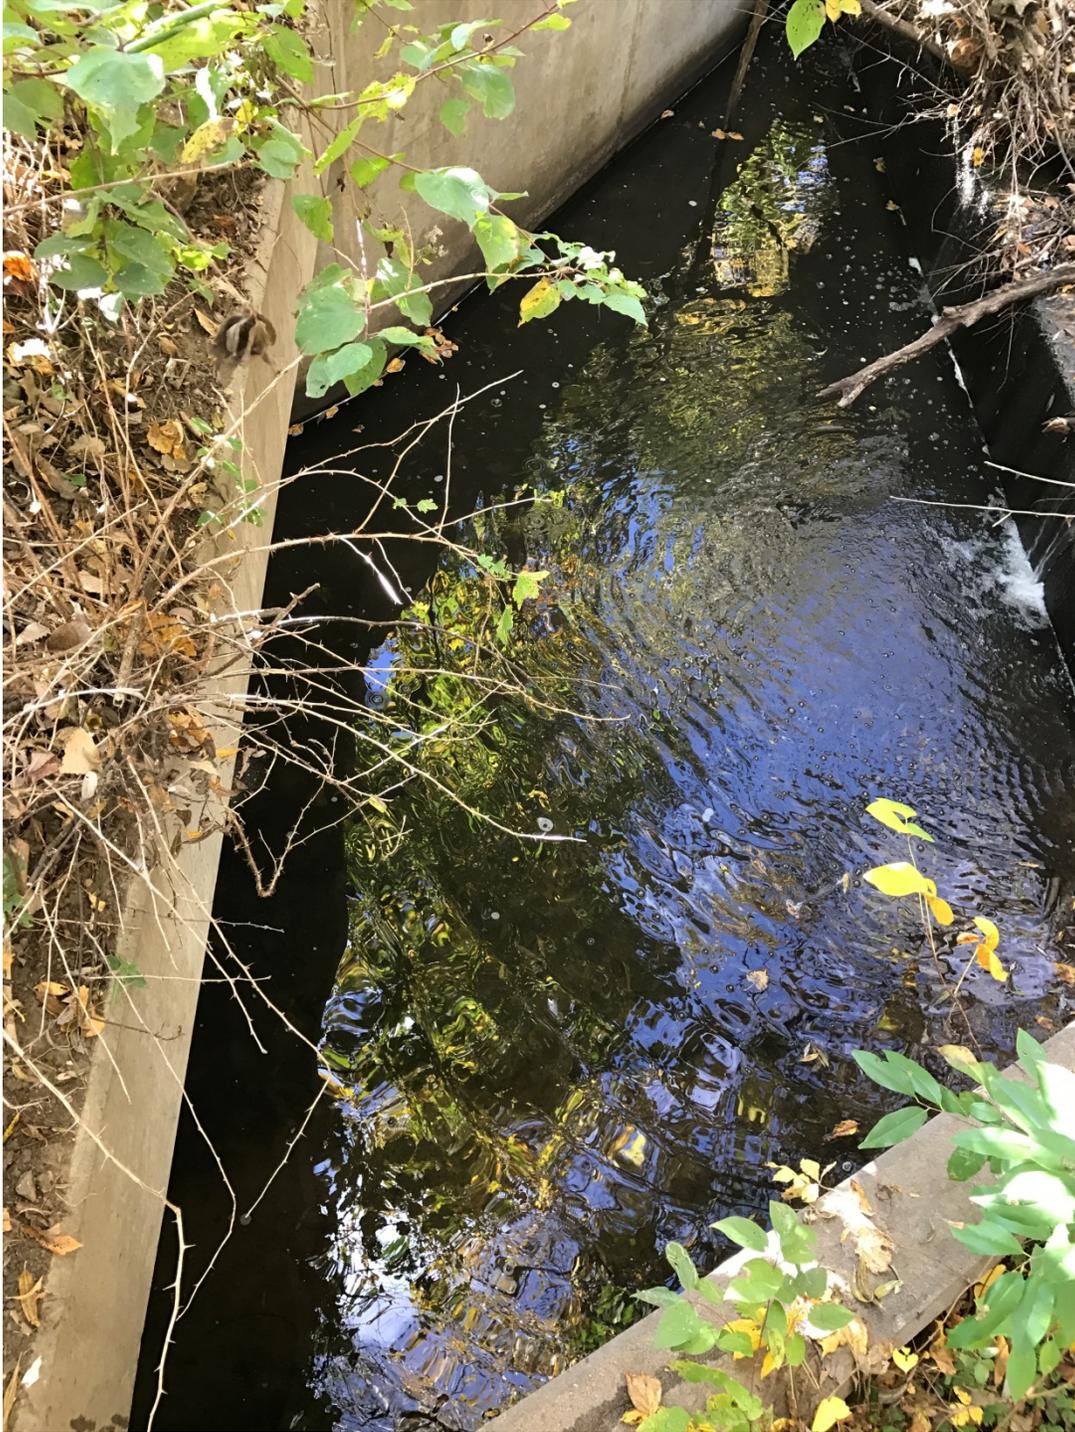
Figure 9. Looking downstream from Site F3 on October 19, 2016. Collector's comments: "Little to no flow. Turbid water. Blue-green substance almost completely covers surface of water. Little to no algae."

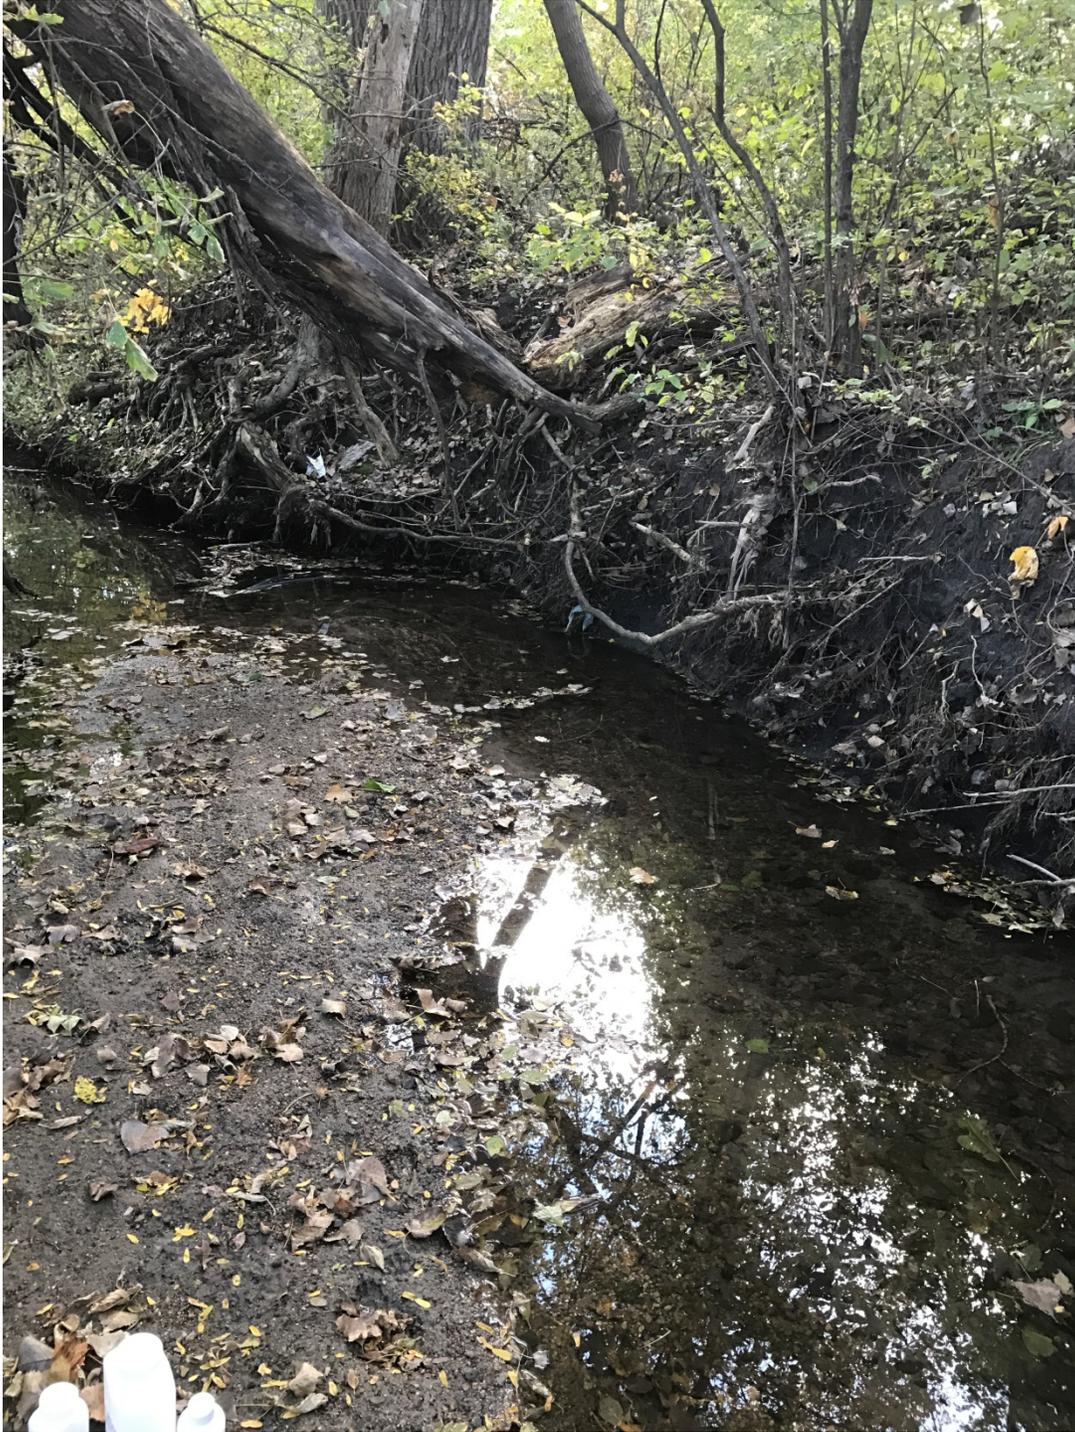
Figure 11. Looking downstream from site G4 on October 19, 2016. Collector's comments: "Clear water. Low flow, little to no algae. Abundance of woody debris."

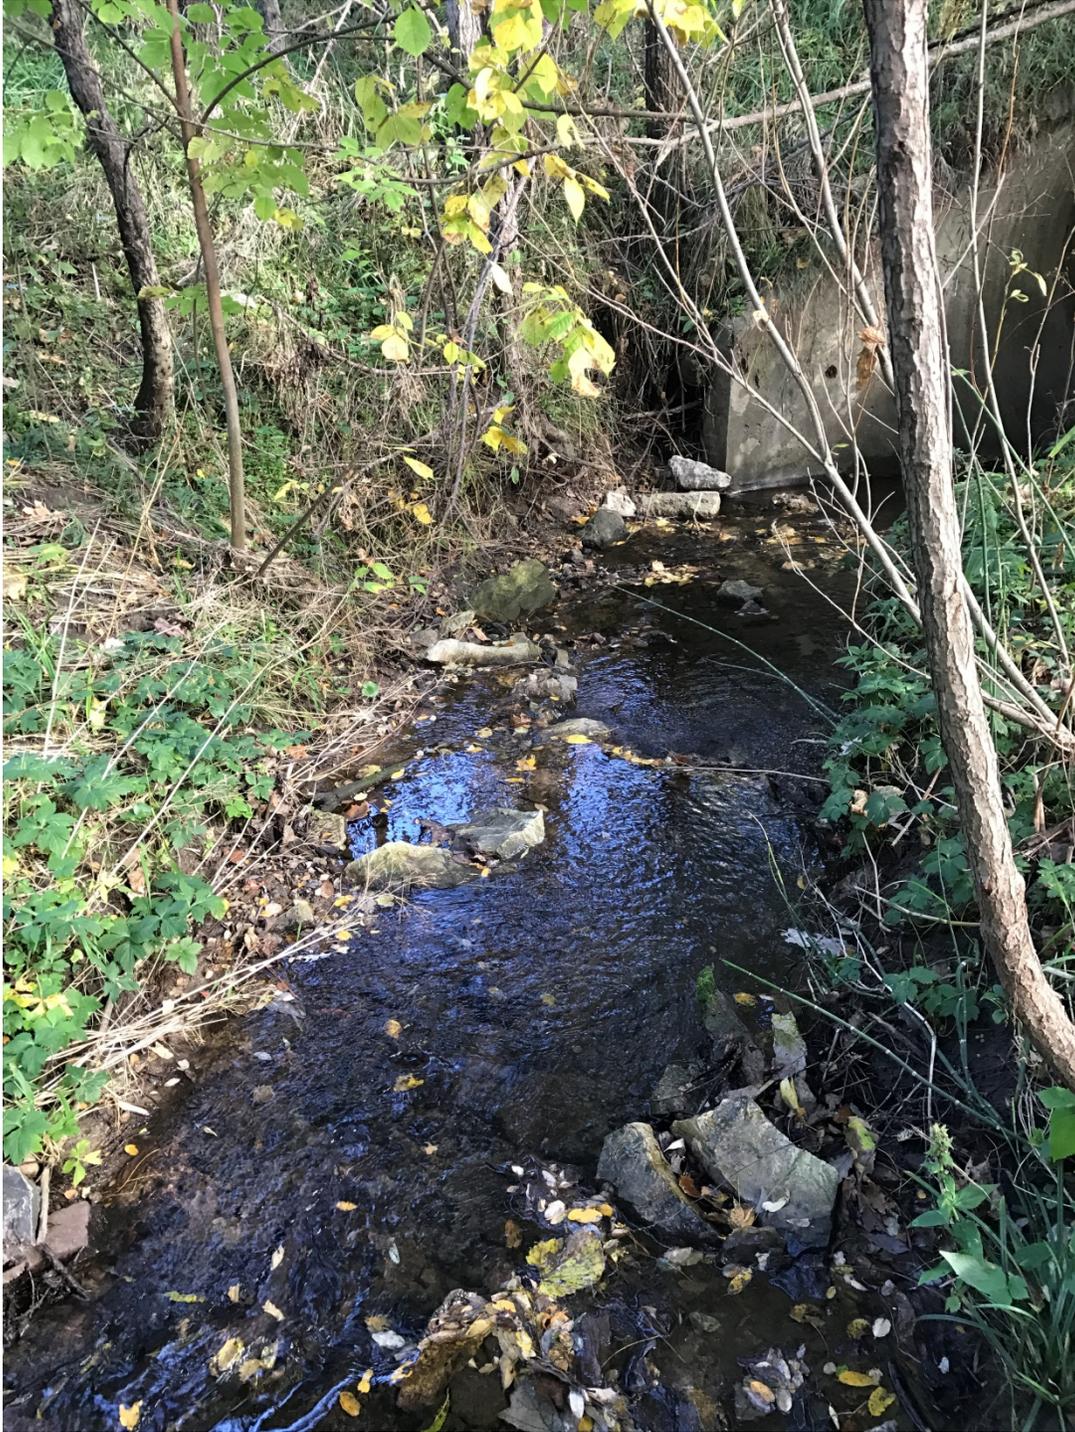
Figure 13. Looking downstream from site I5 on October 19, 2016. Collector's comments: "Clear water, moderate filamentous algae and woody debris. Good flow."

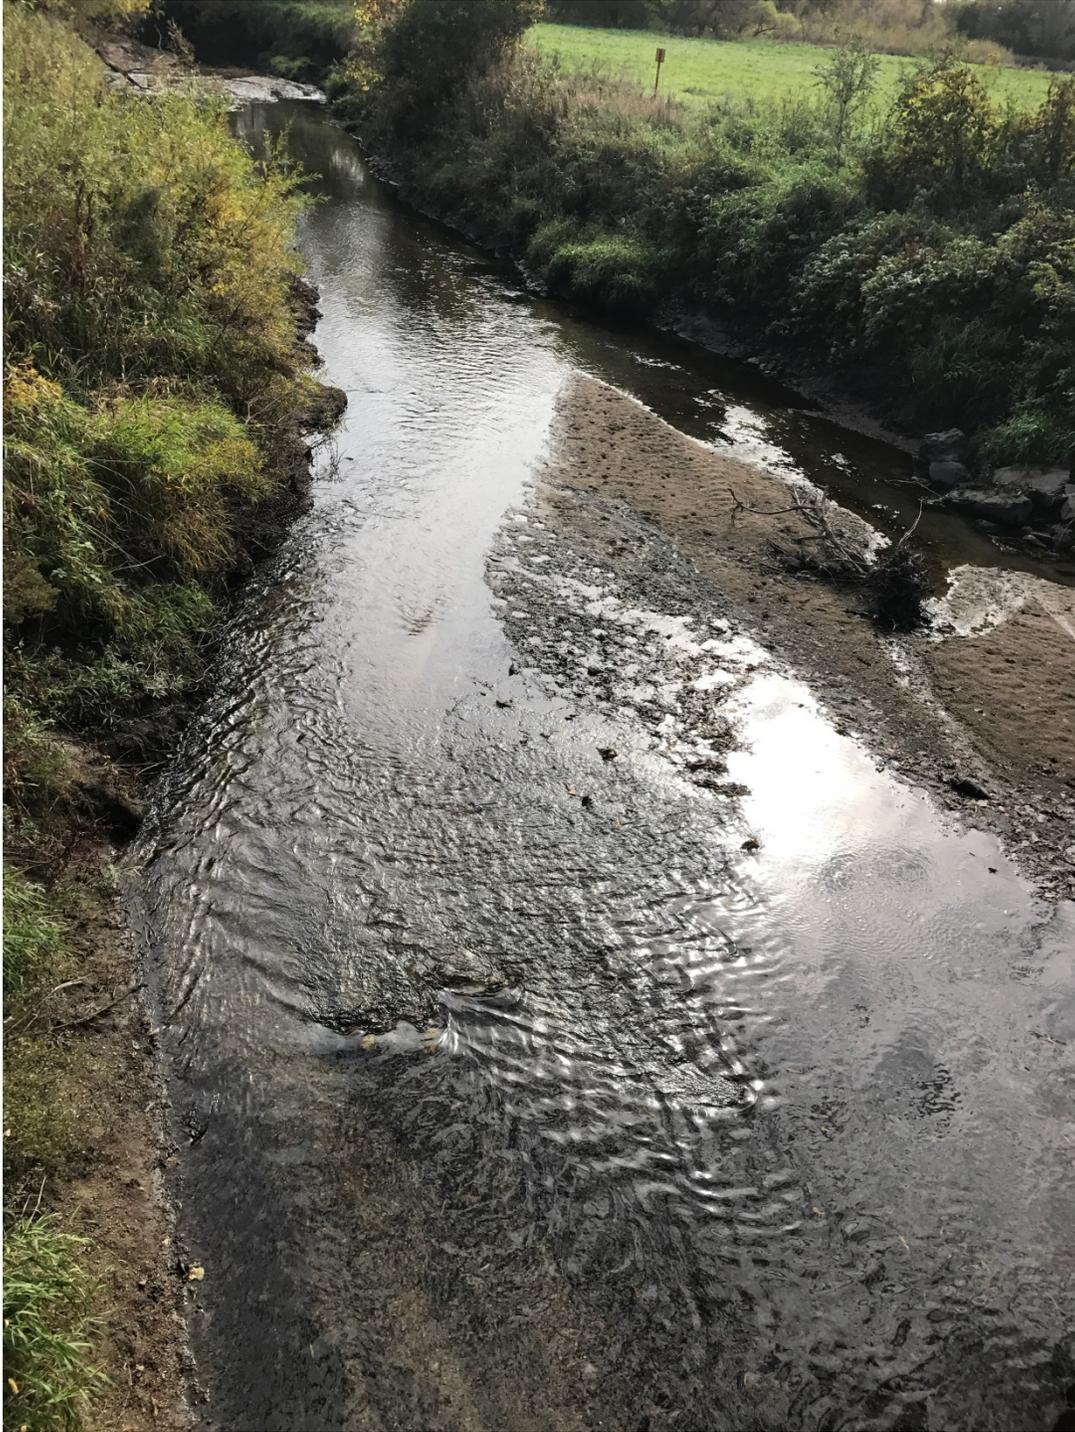
Figure 15. Looking downstream from site LB6 on October 19, 2016. Collector's comments: "Water clear, shallow with good flow. No algae or debris."

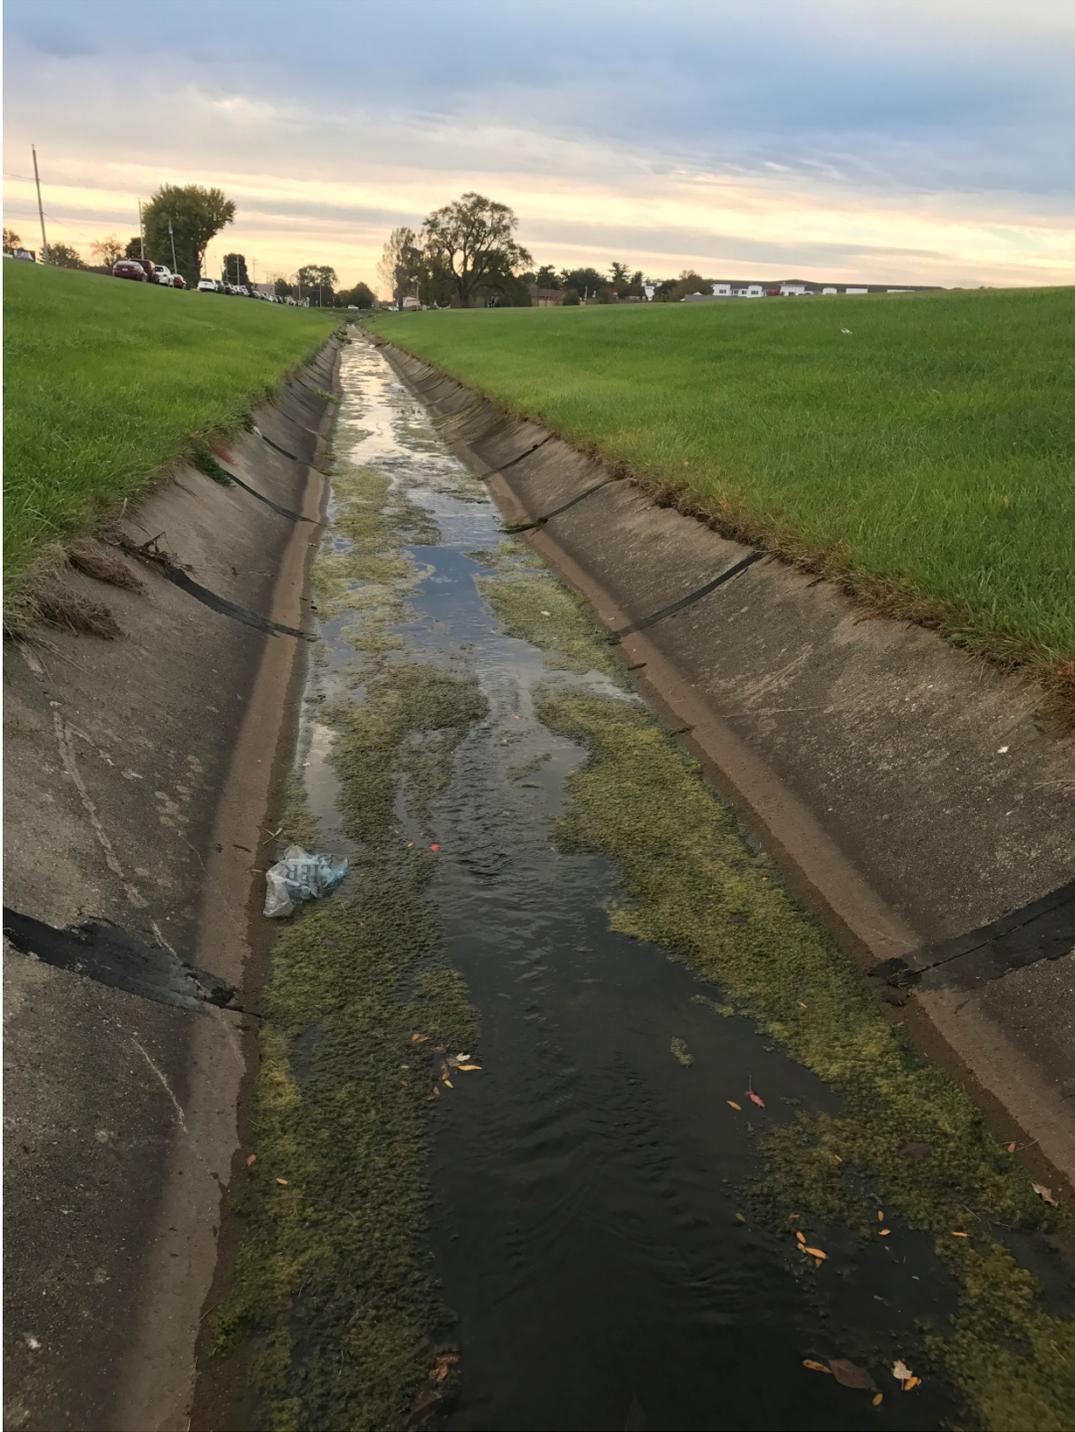
Figure 17. Looking downstream from site S7 on October 19, 2016. Collector's comments: "Abundant filamentous algae, surface algae, and trash. Moderate flow, clear water."

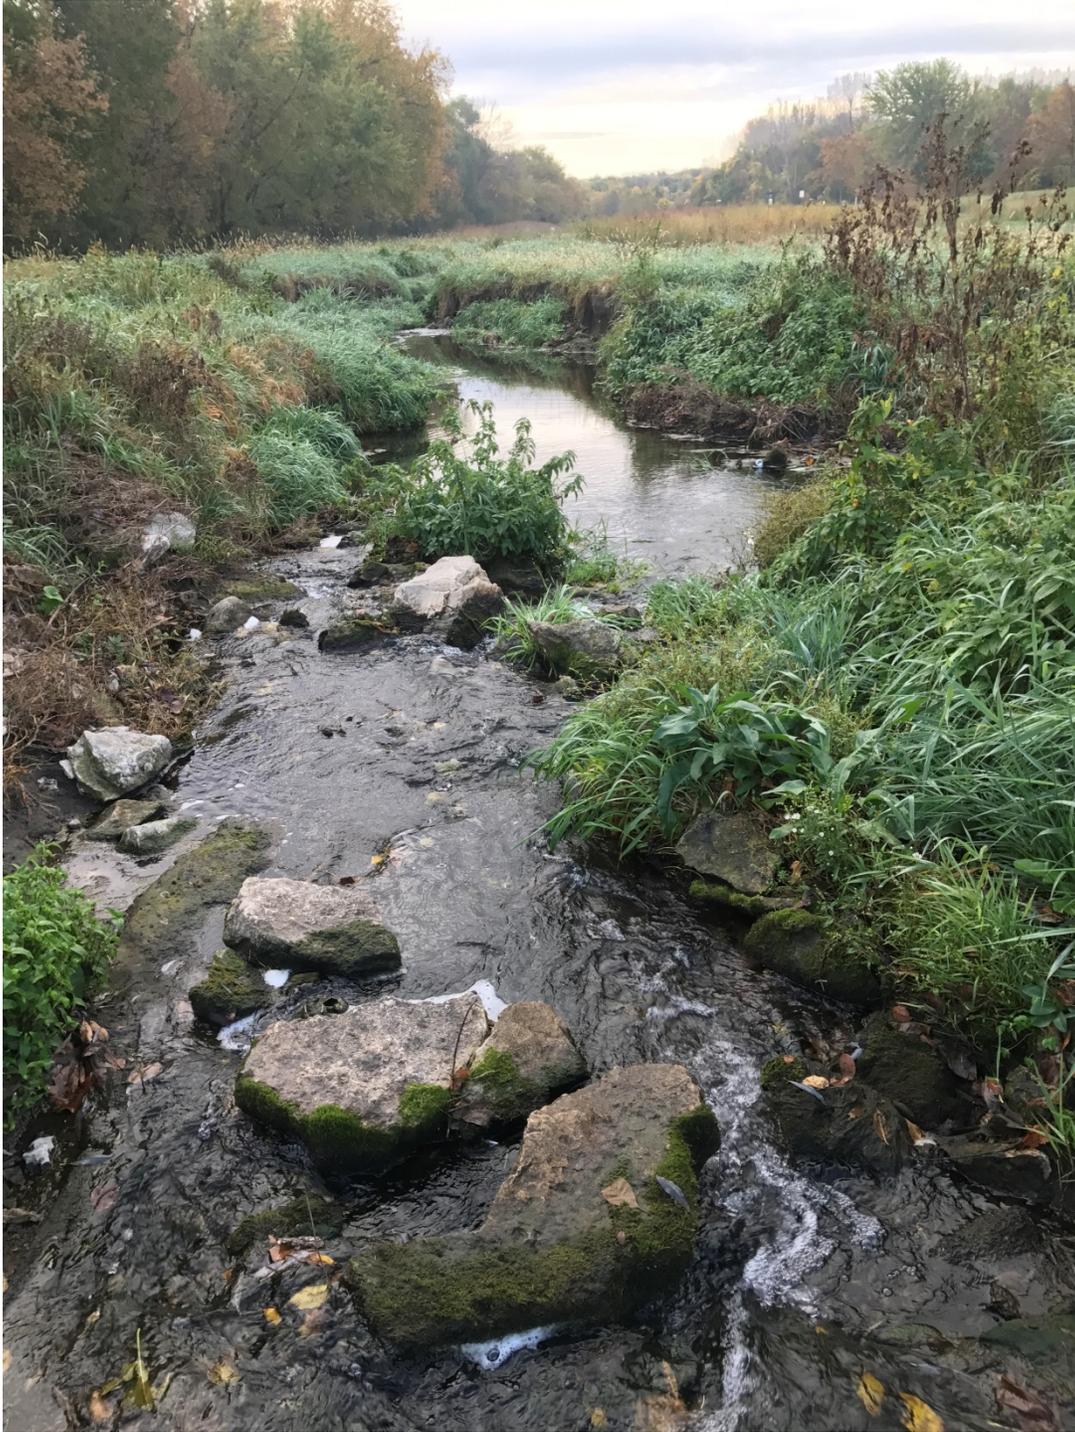
Figure 19. Looking downstream from site S8 on October 19. Collector's comments: "Moderate filamentous algae, leaves, and trash. Good flow and clear water."

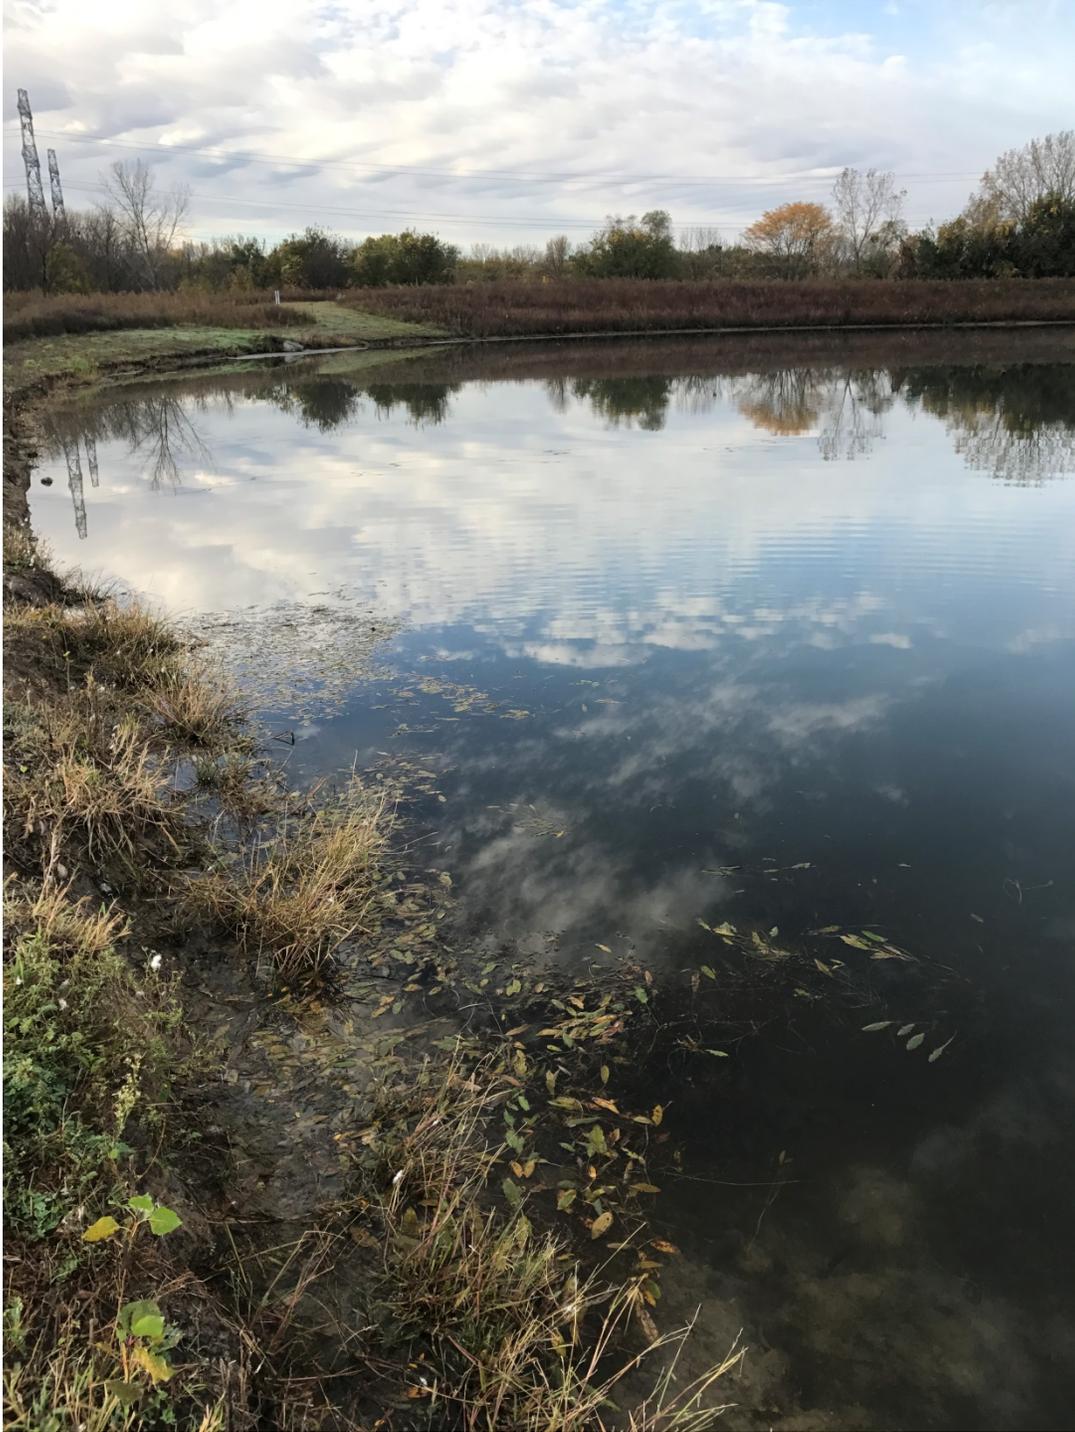
Figure 21. Looking south from the Terra Lake sampling location on October 19, 2016. Collector's comment: "Clear water, mild amounts of aquatic vegetation, and surface algae."
